Quality Control Study of Avian #B5 White Tile
Interim Report #2

John W. Root, Ph.D.
Mt. Baker Research L.L.C.
2921 Sylvan Street
Bellingham, Washington 98226-4314 USA
Tel: (360) 650-0771
E-Mail: <jackroot@comcast.net>

Release 2.0, October 25, 2007
(©All Rights Reserved)

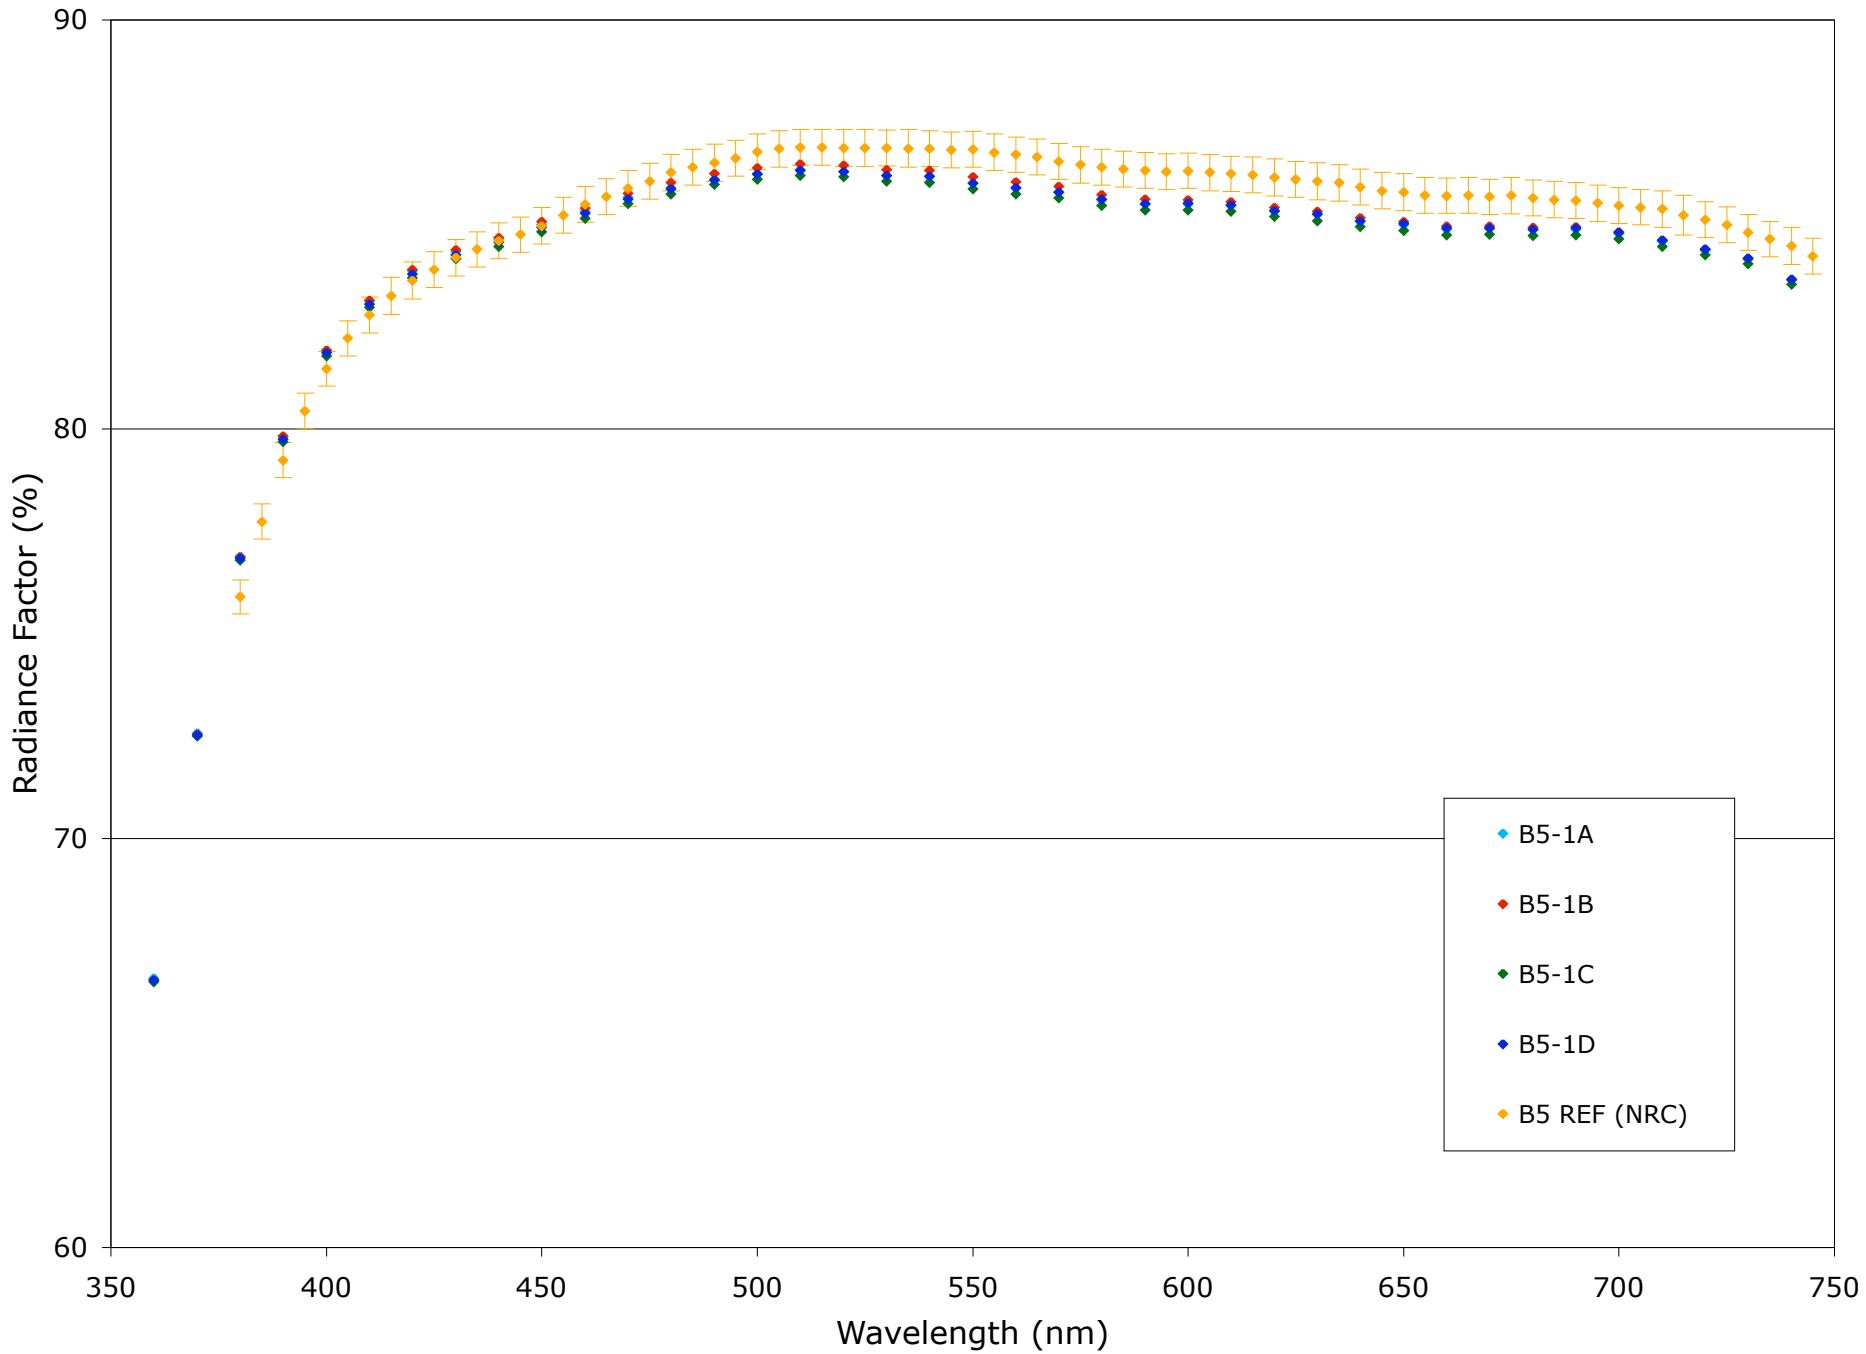
(45/0) Radiance Factors for Sectors A-D of B5-1 Tile

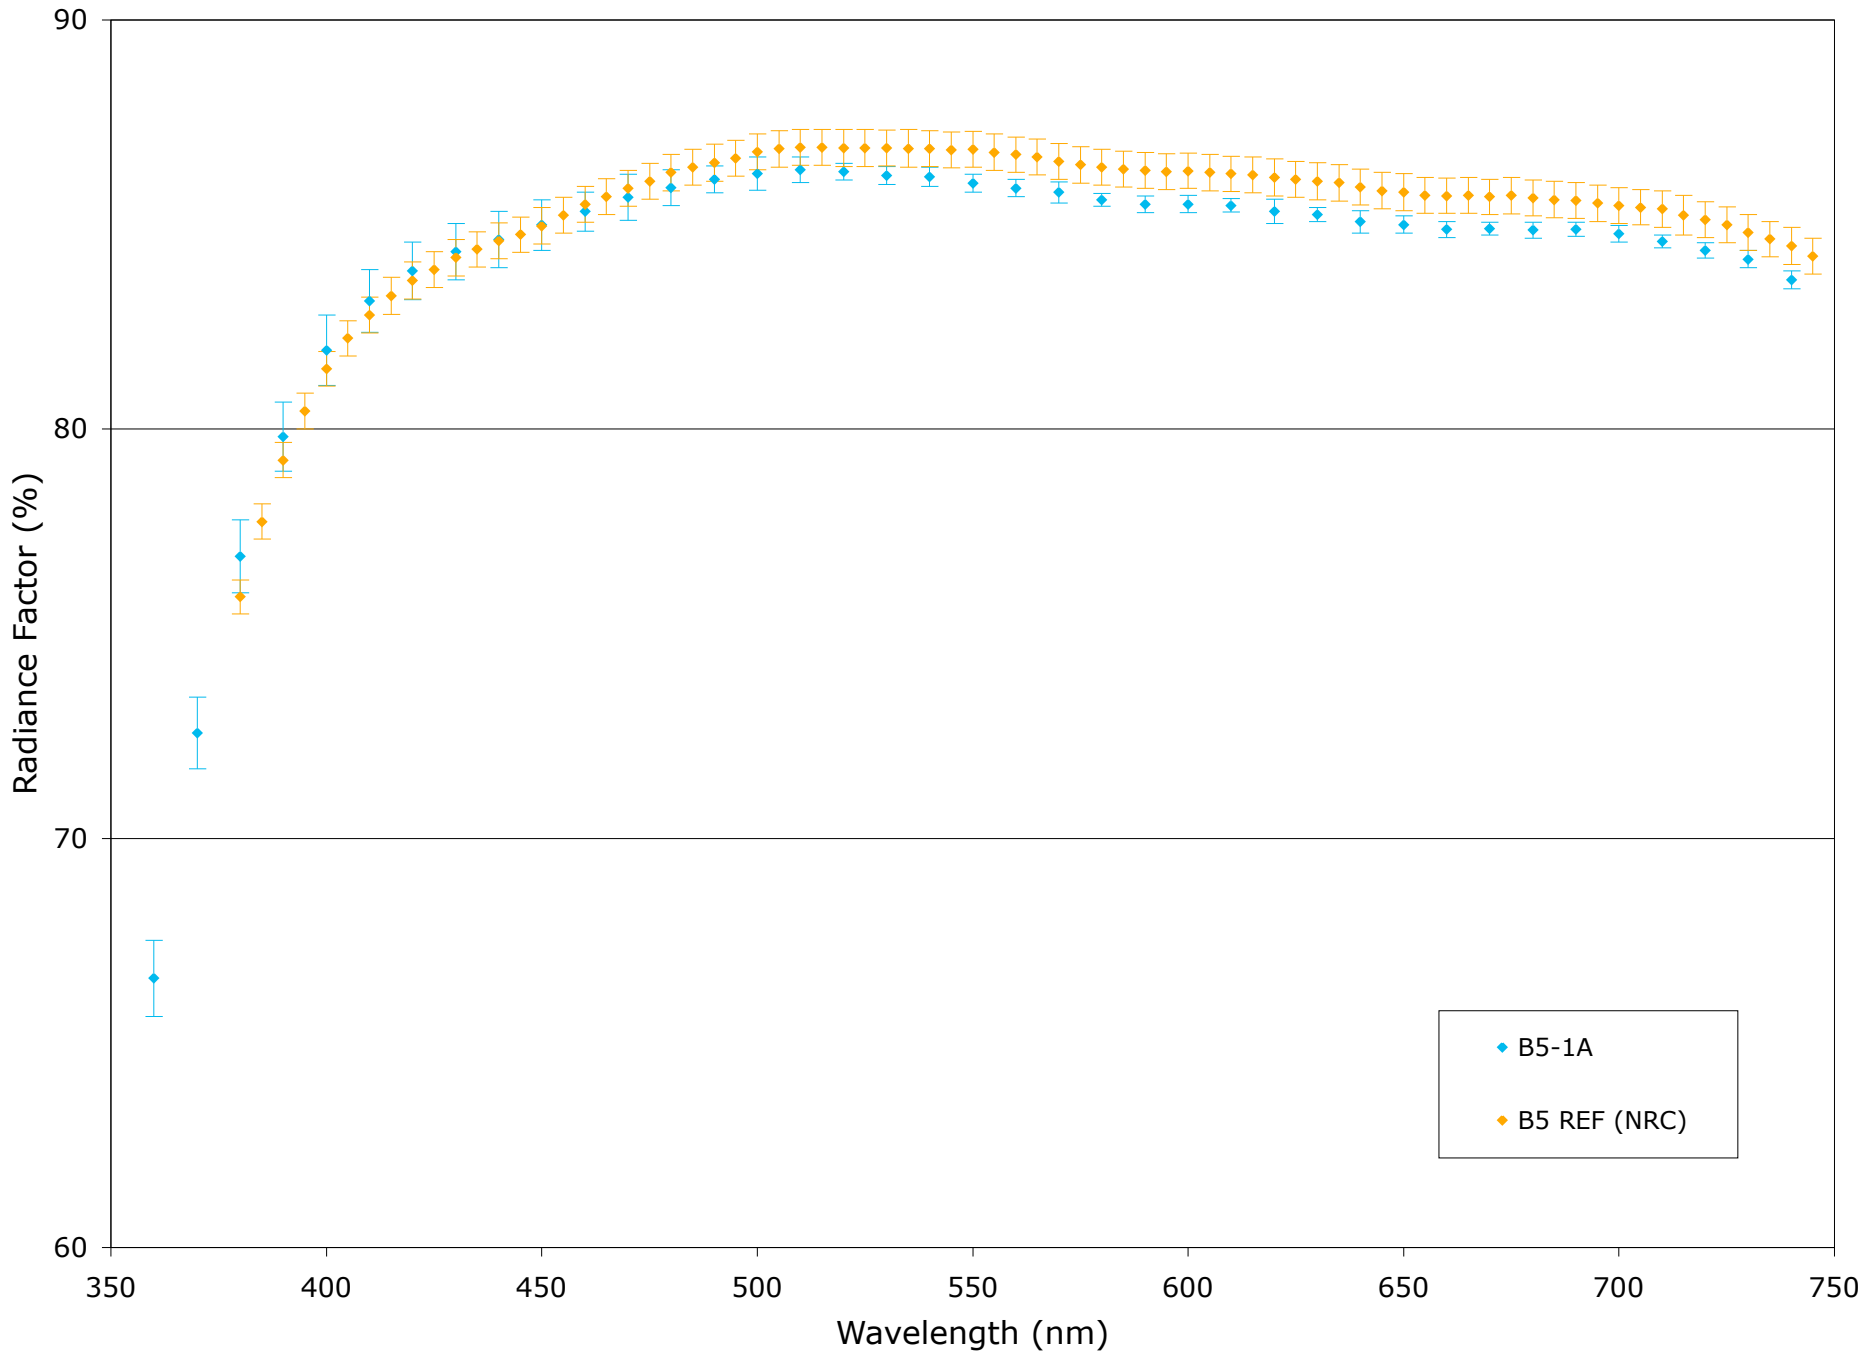
(45/0) Radiance Factors for Sector A of B5-1 Tile

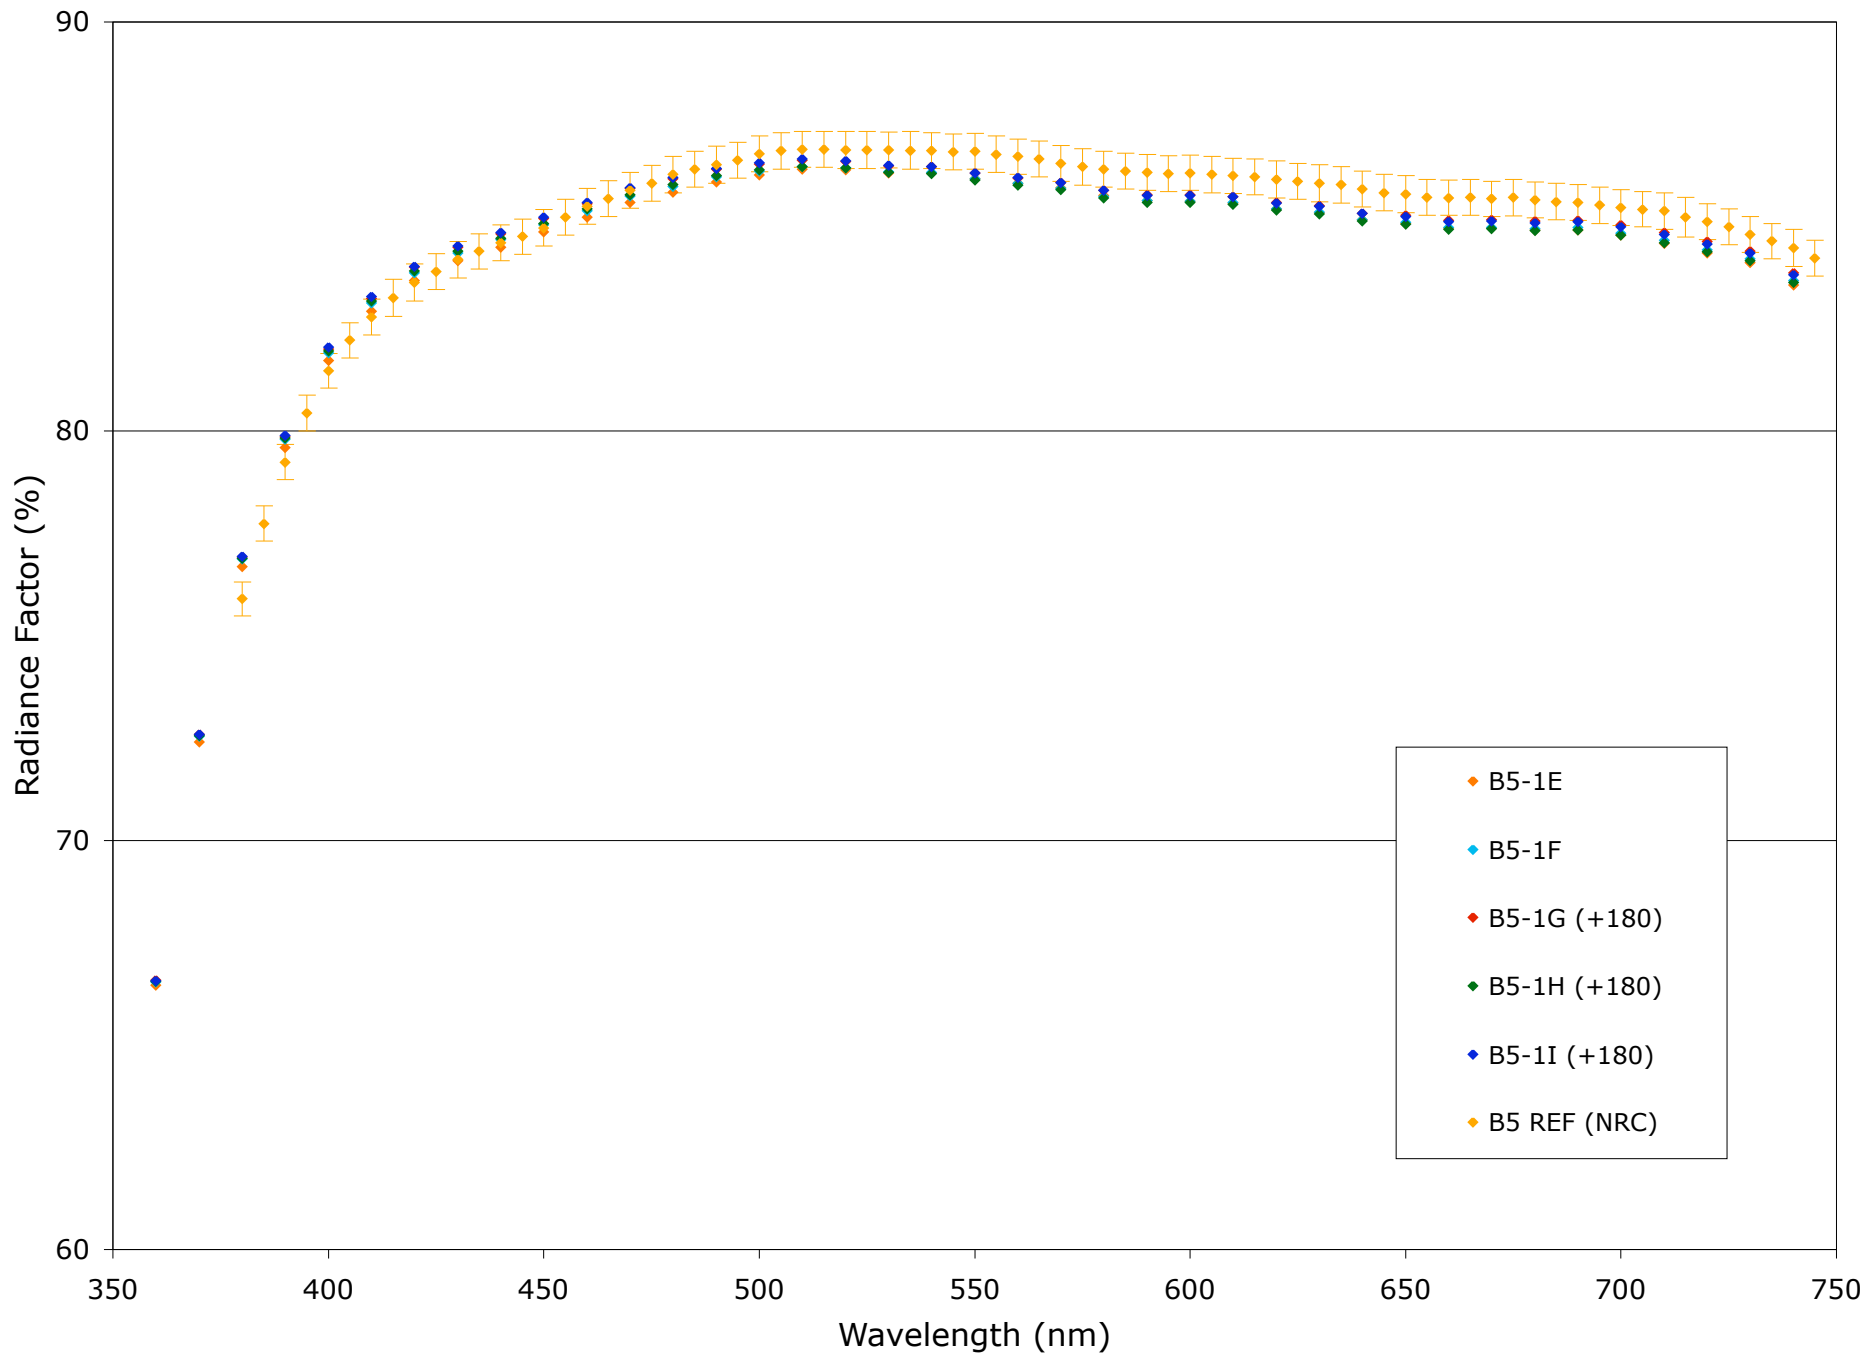
(45/0) Radiance Factors for Sectors E-I of B5-1 Tile

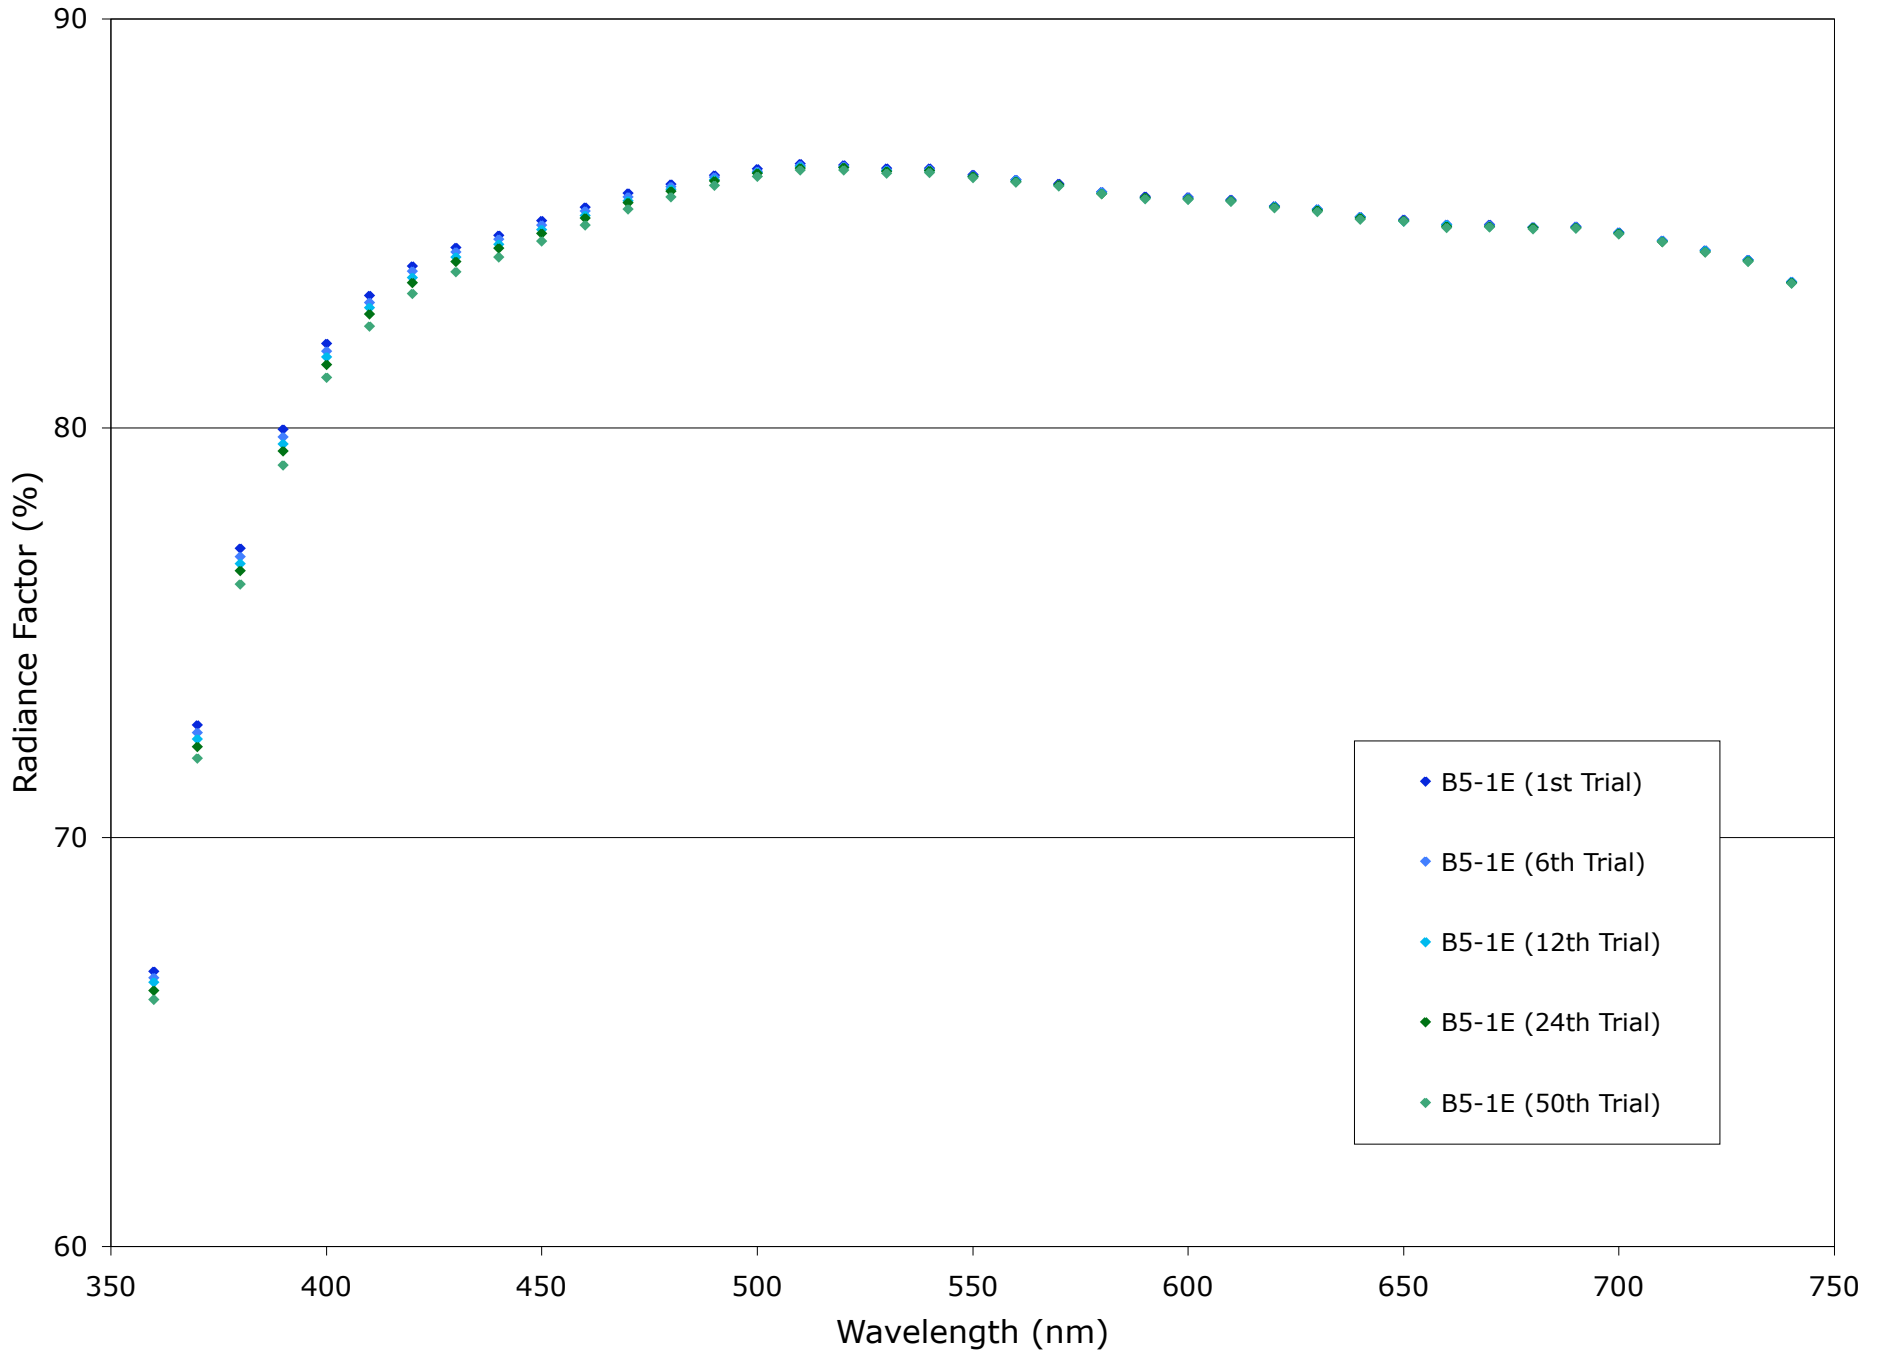
Systematic Loss of Reflectivity for B5-1 Tile with UV Exposure

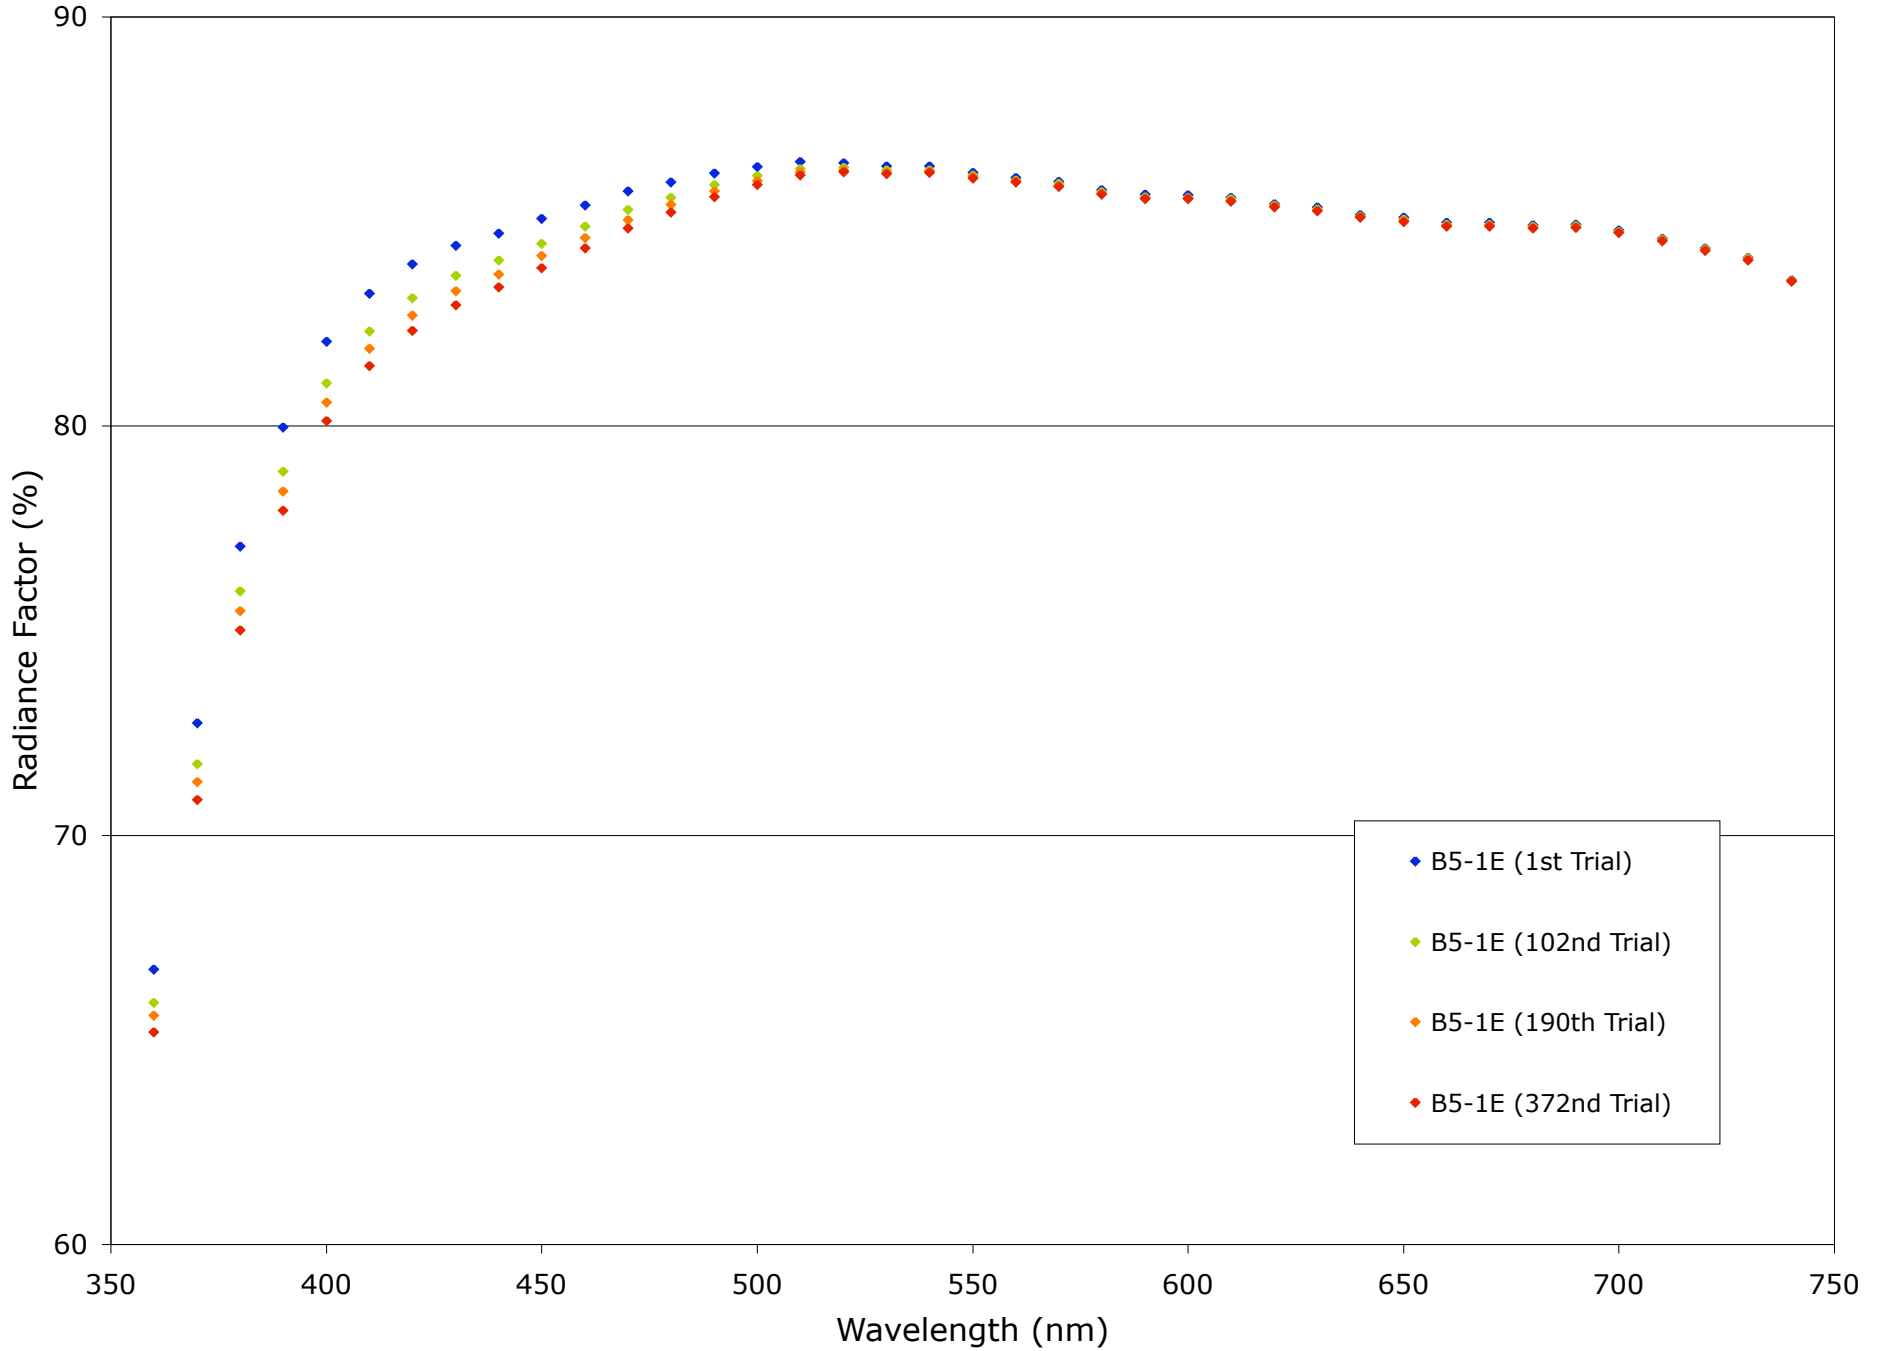
Systematic Loss of Reflectivity for B5-1 Tile with UV Exposure

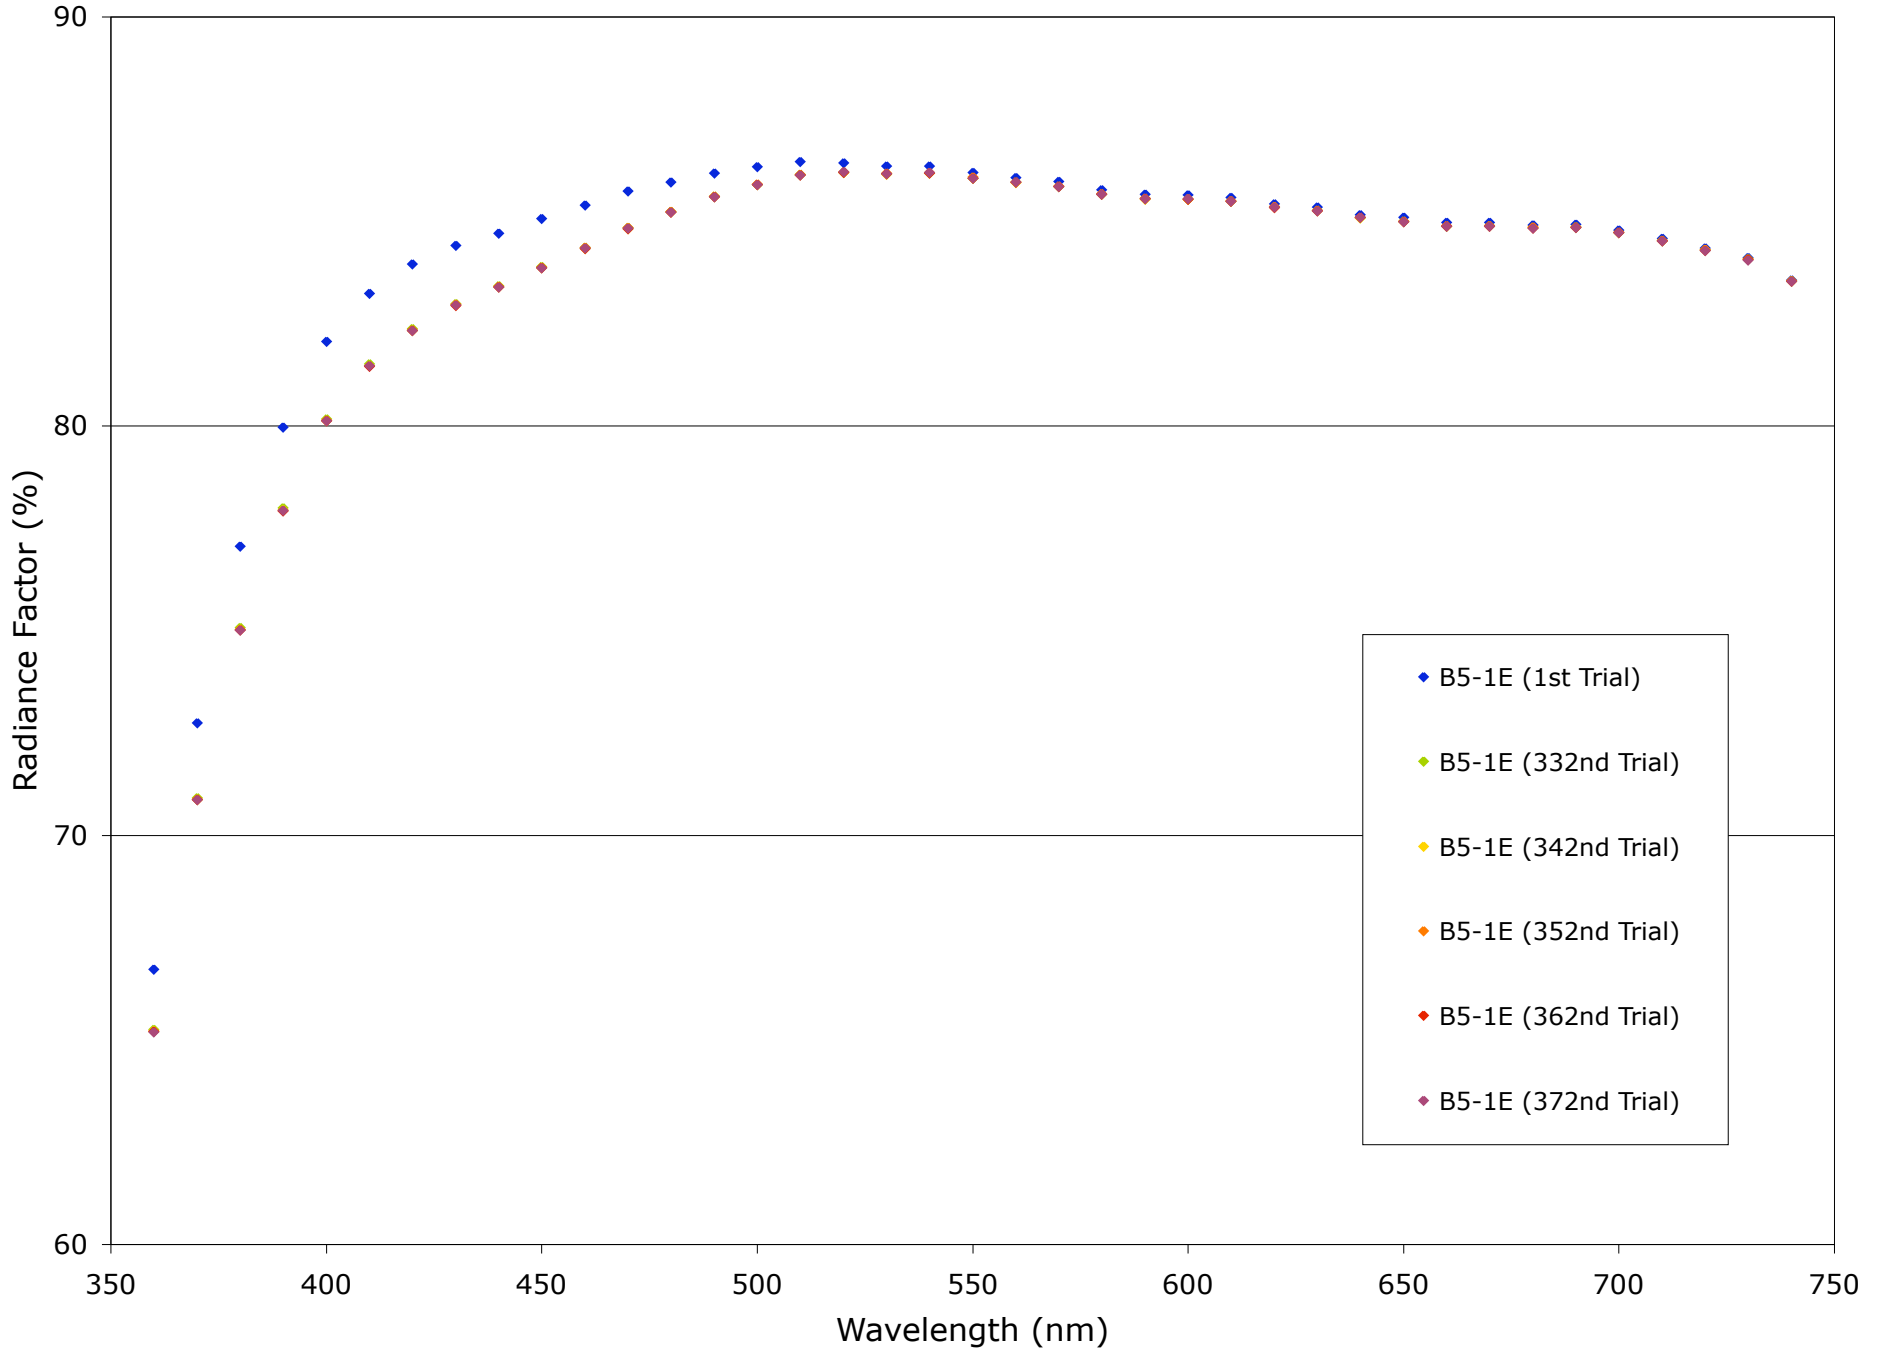
Saturation of Reflectivity Loss for B5-1 Tile with UV Exposure

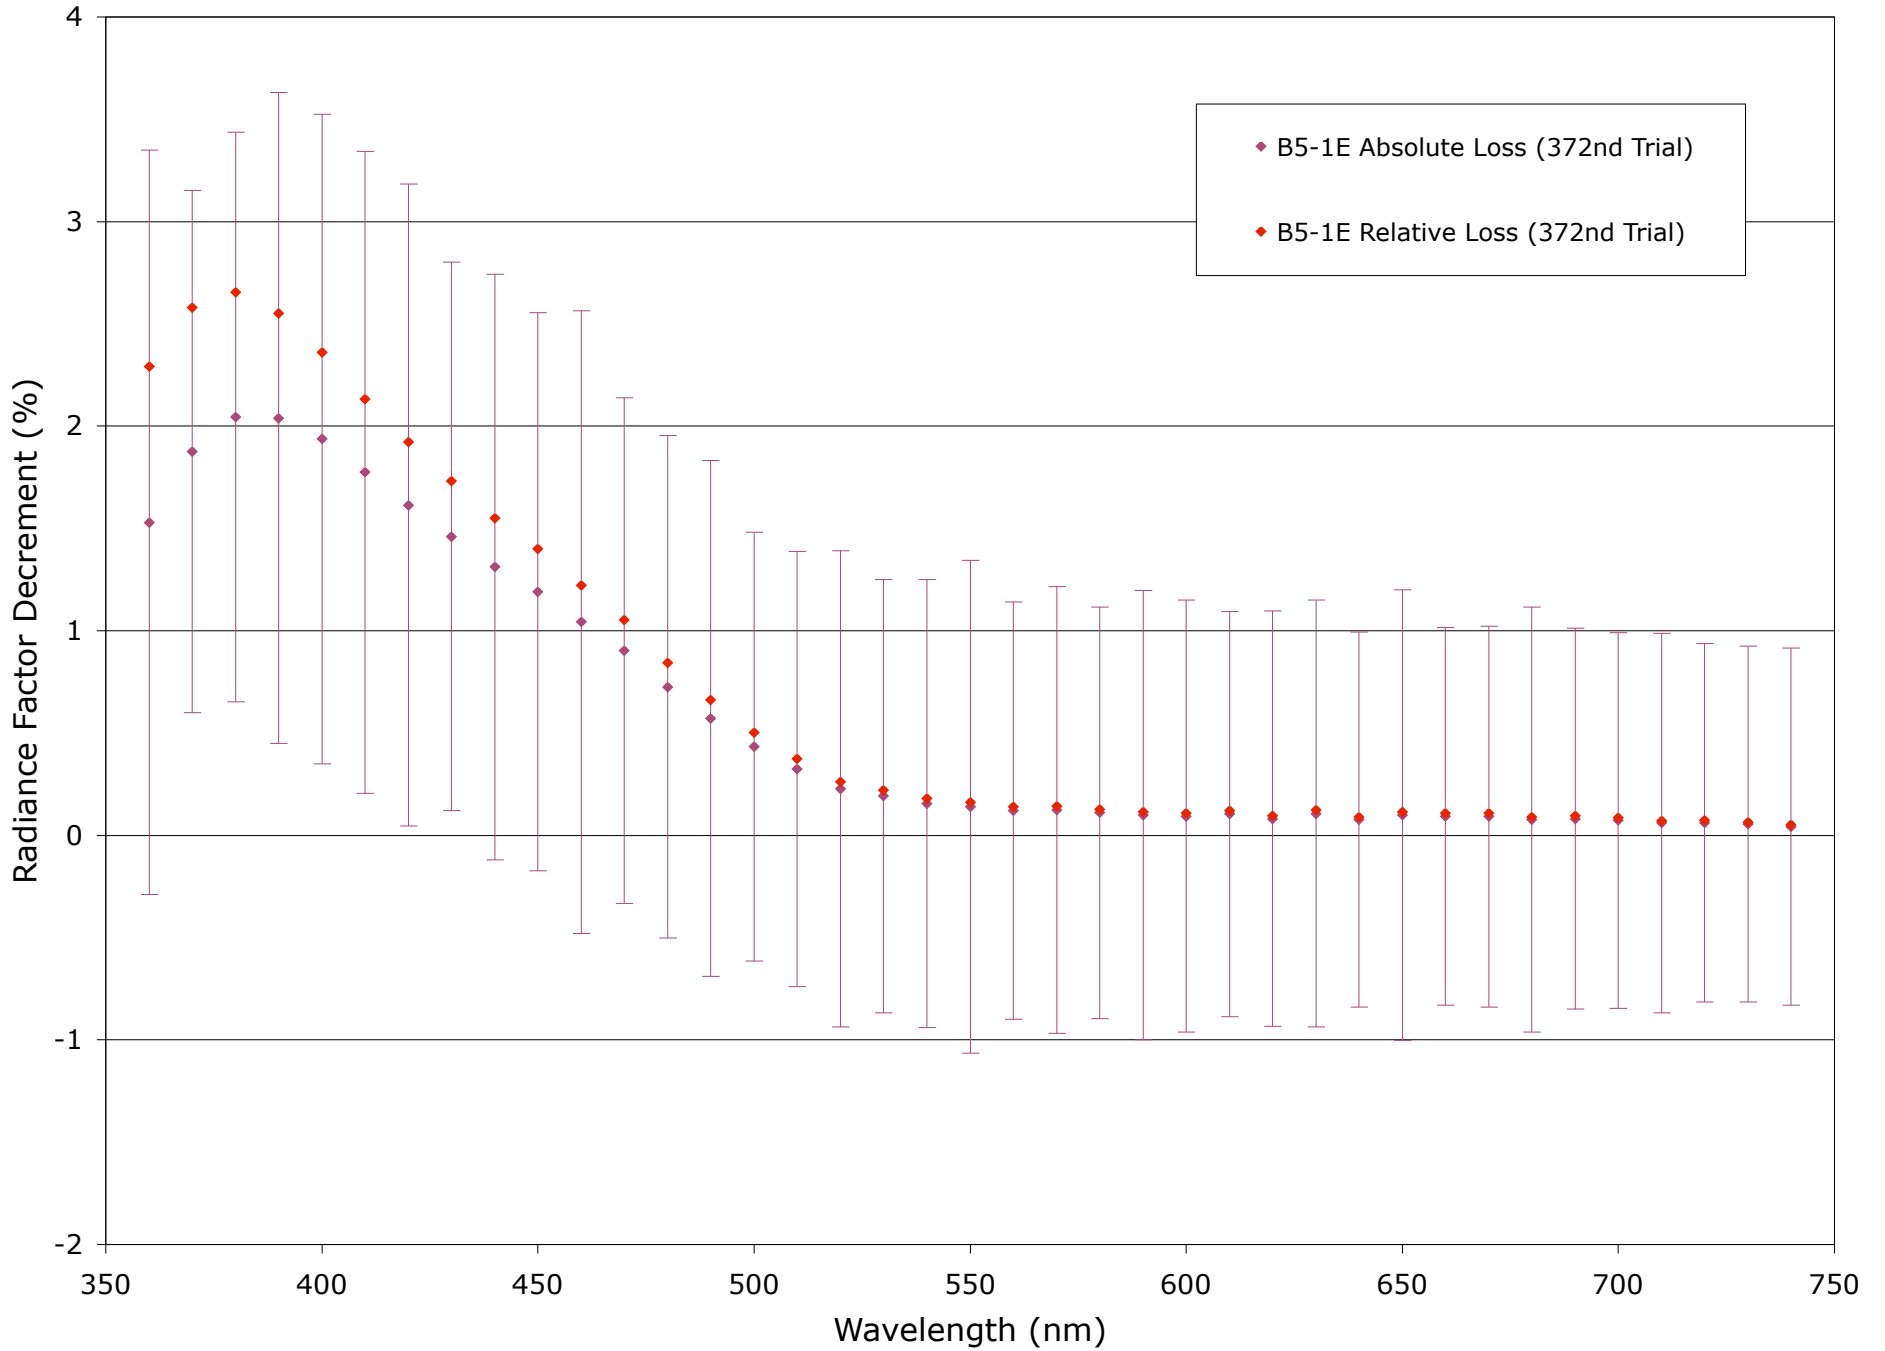
Saturation of Reflectivity Loss for B5-1 Tile with UV Exposure

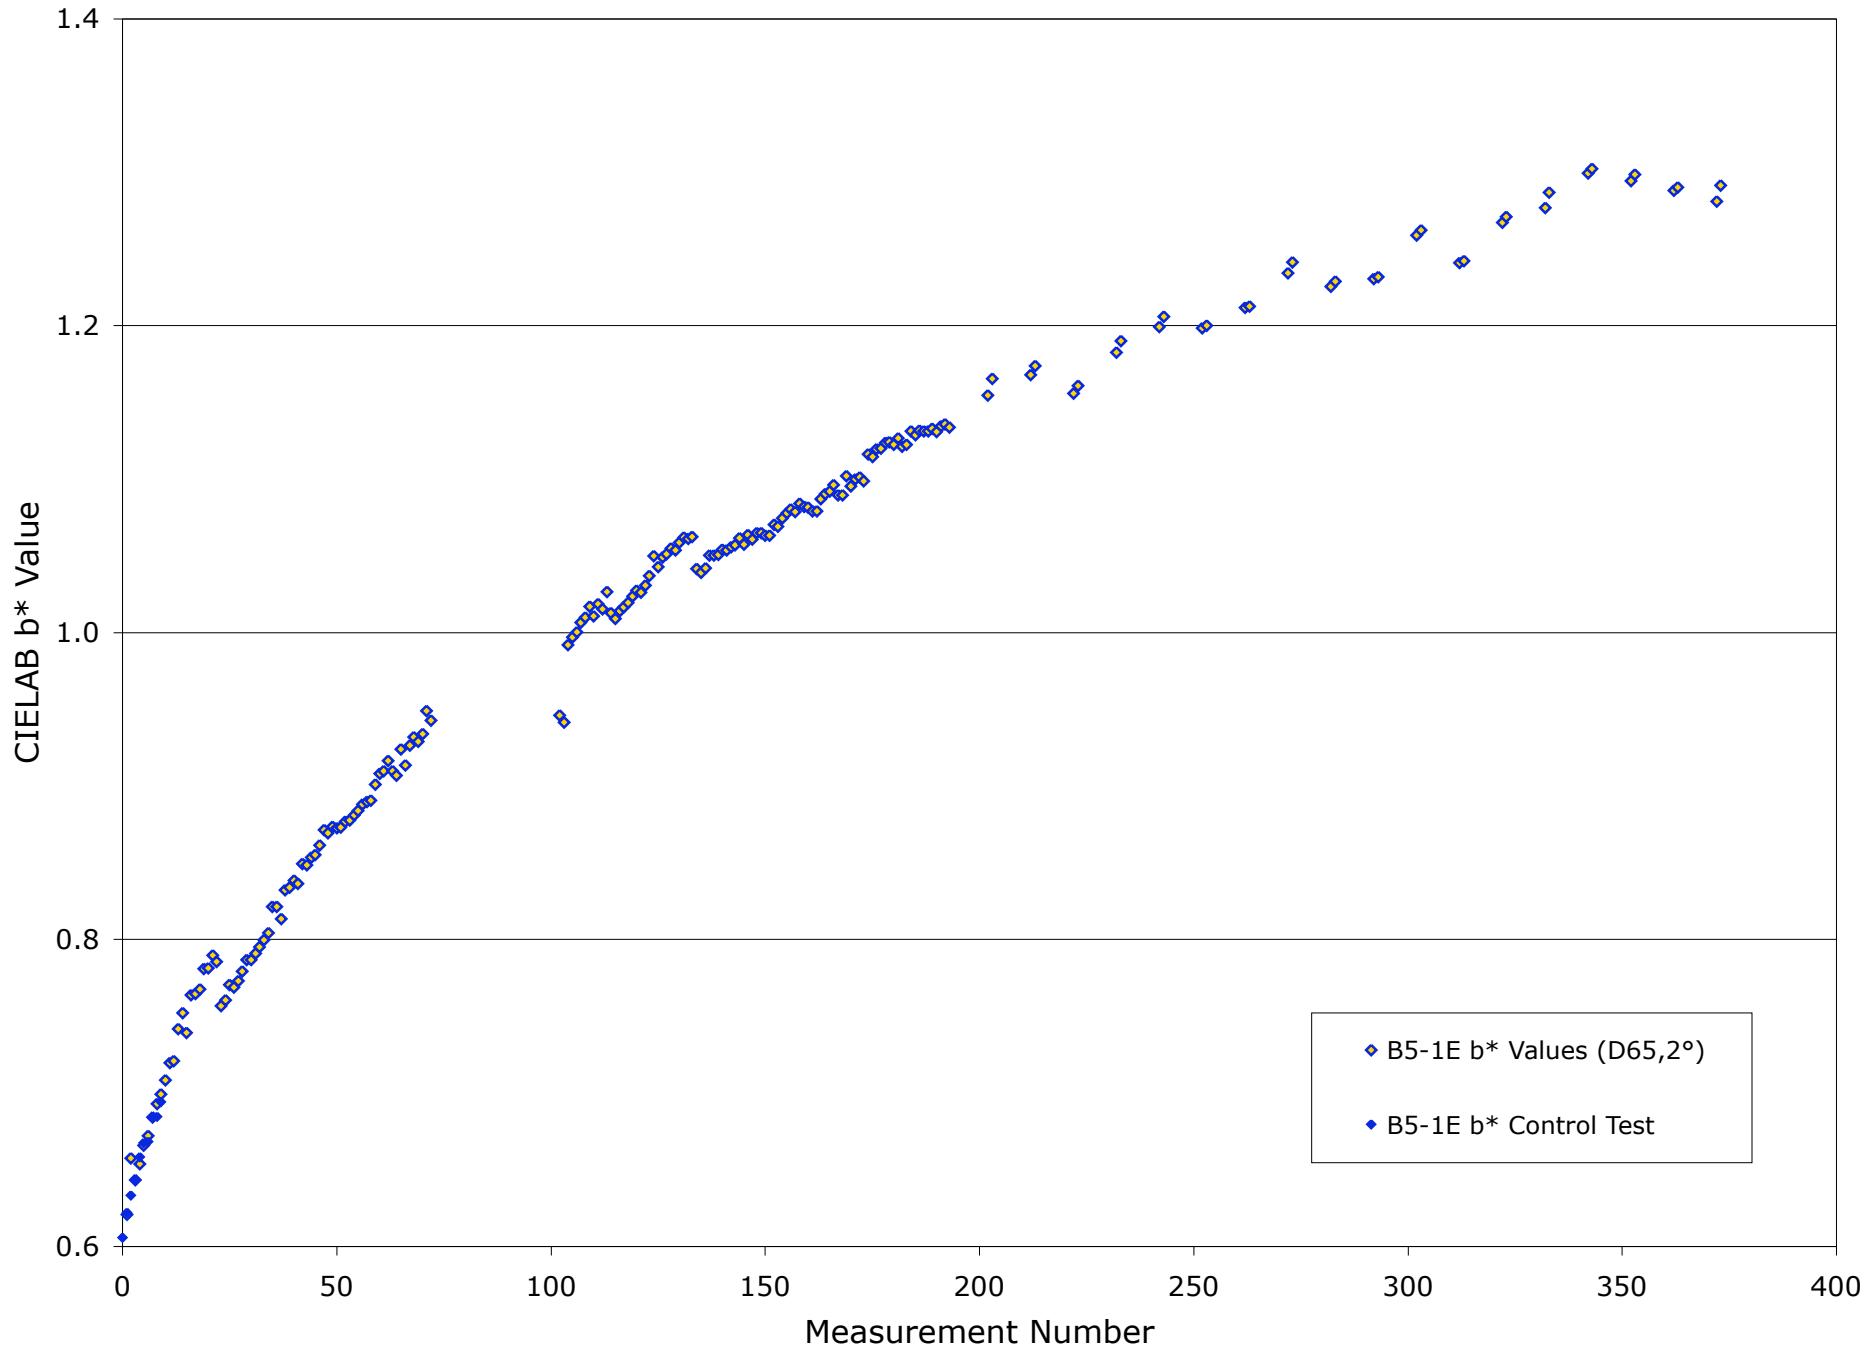
Change in CIELAB b* for B5-1 Tile with UV Exposure

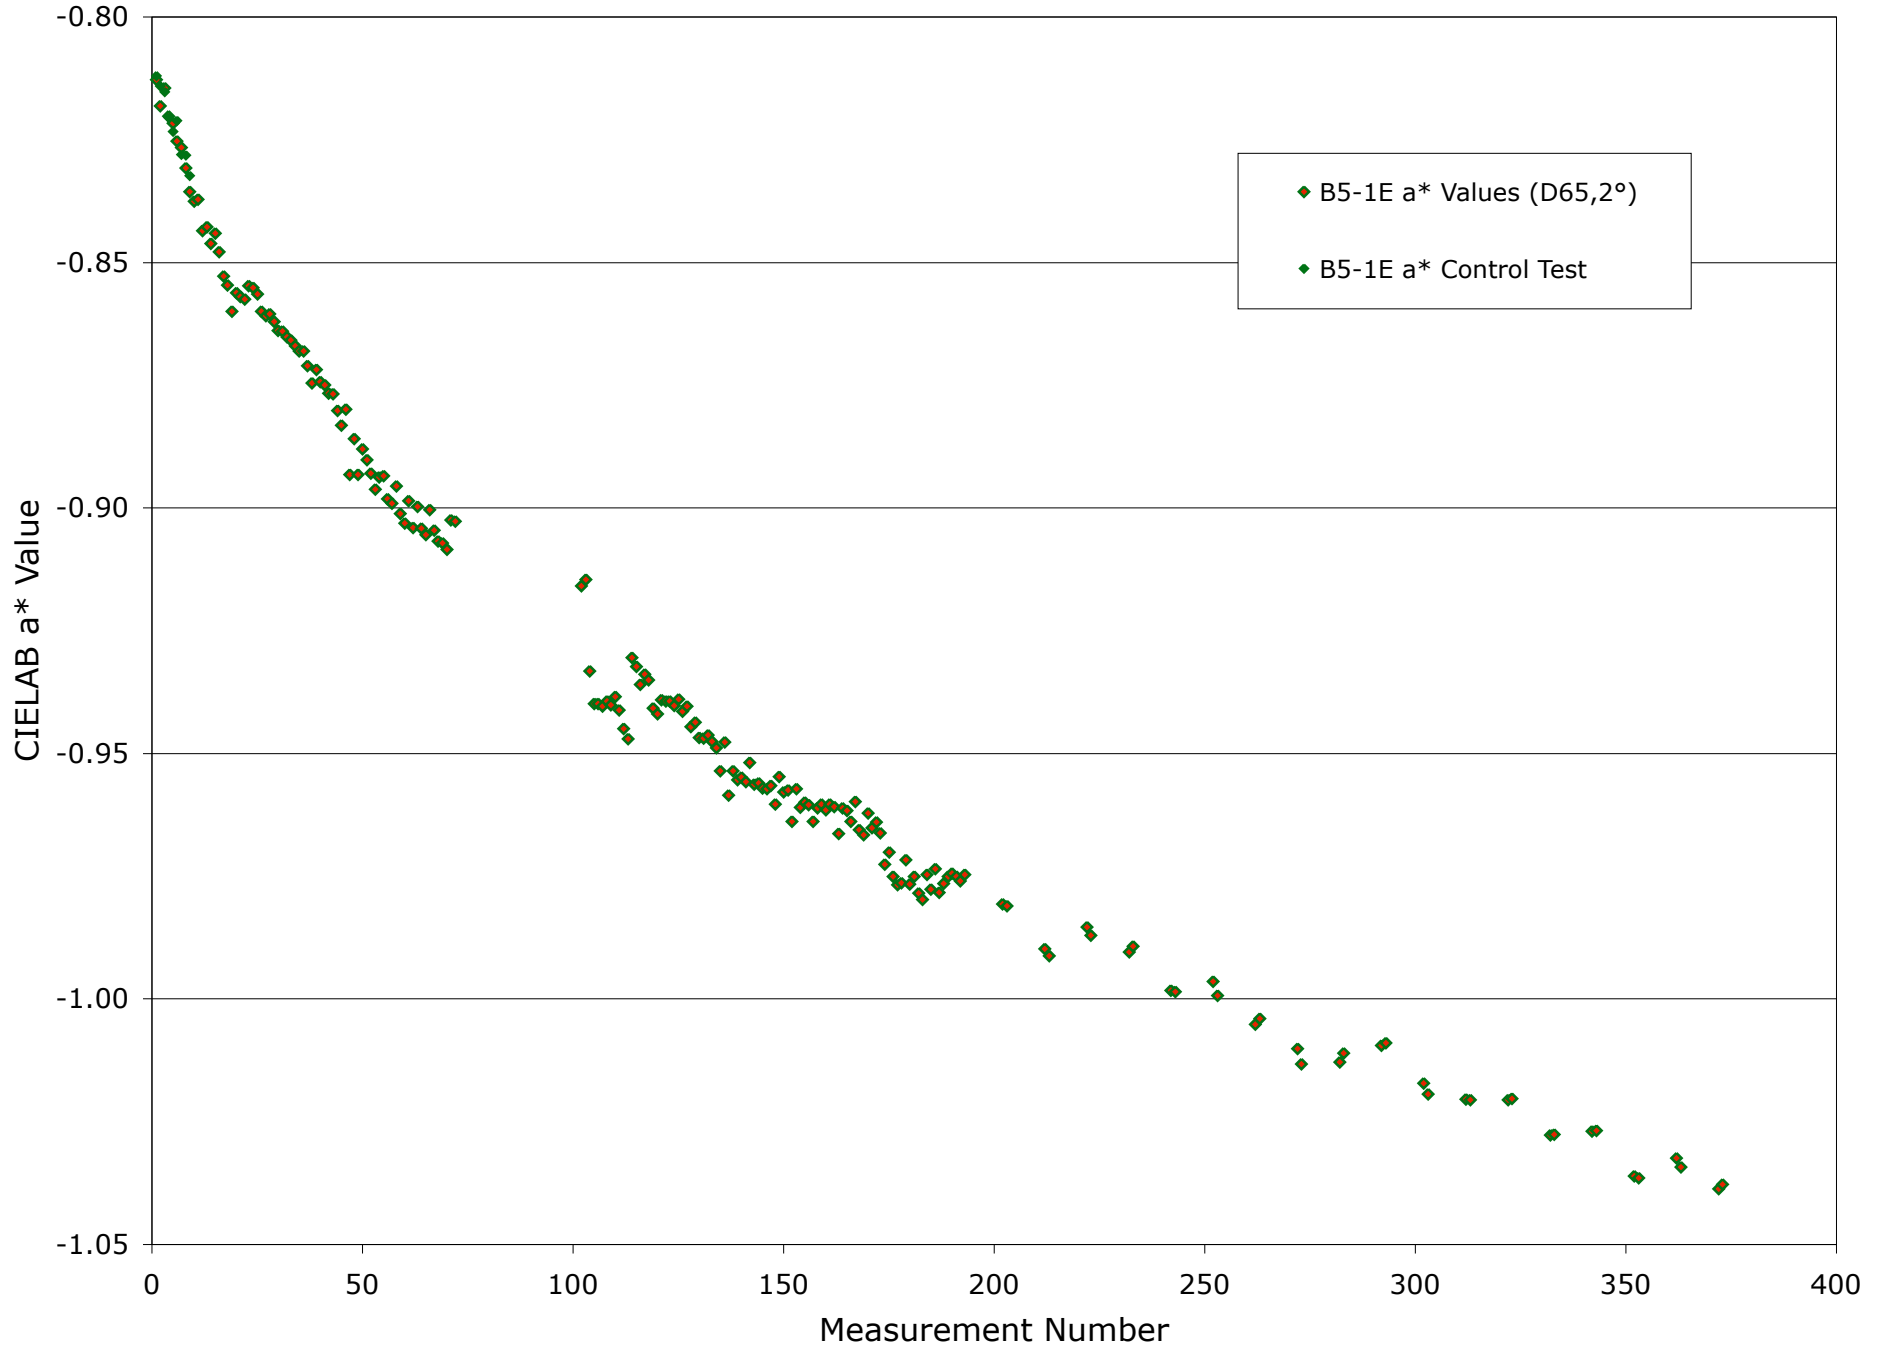
Change in CIELAB a* for B5-1 Tile with UV Exposure
