Quality Control Study of Avian #B5 White Tile
Interim Report #2

John W. Root, Ph.D.
Mt. Baker Research L.L.C.
2921 Sylvan Street
Bellingham, Washington 98226-4314 USA
Tel: (360) 650-0771
E-Mail: <jackroot@comcast.net>

Release 2.0, October 25, 2007
(©All Rights Reserved)

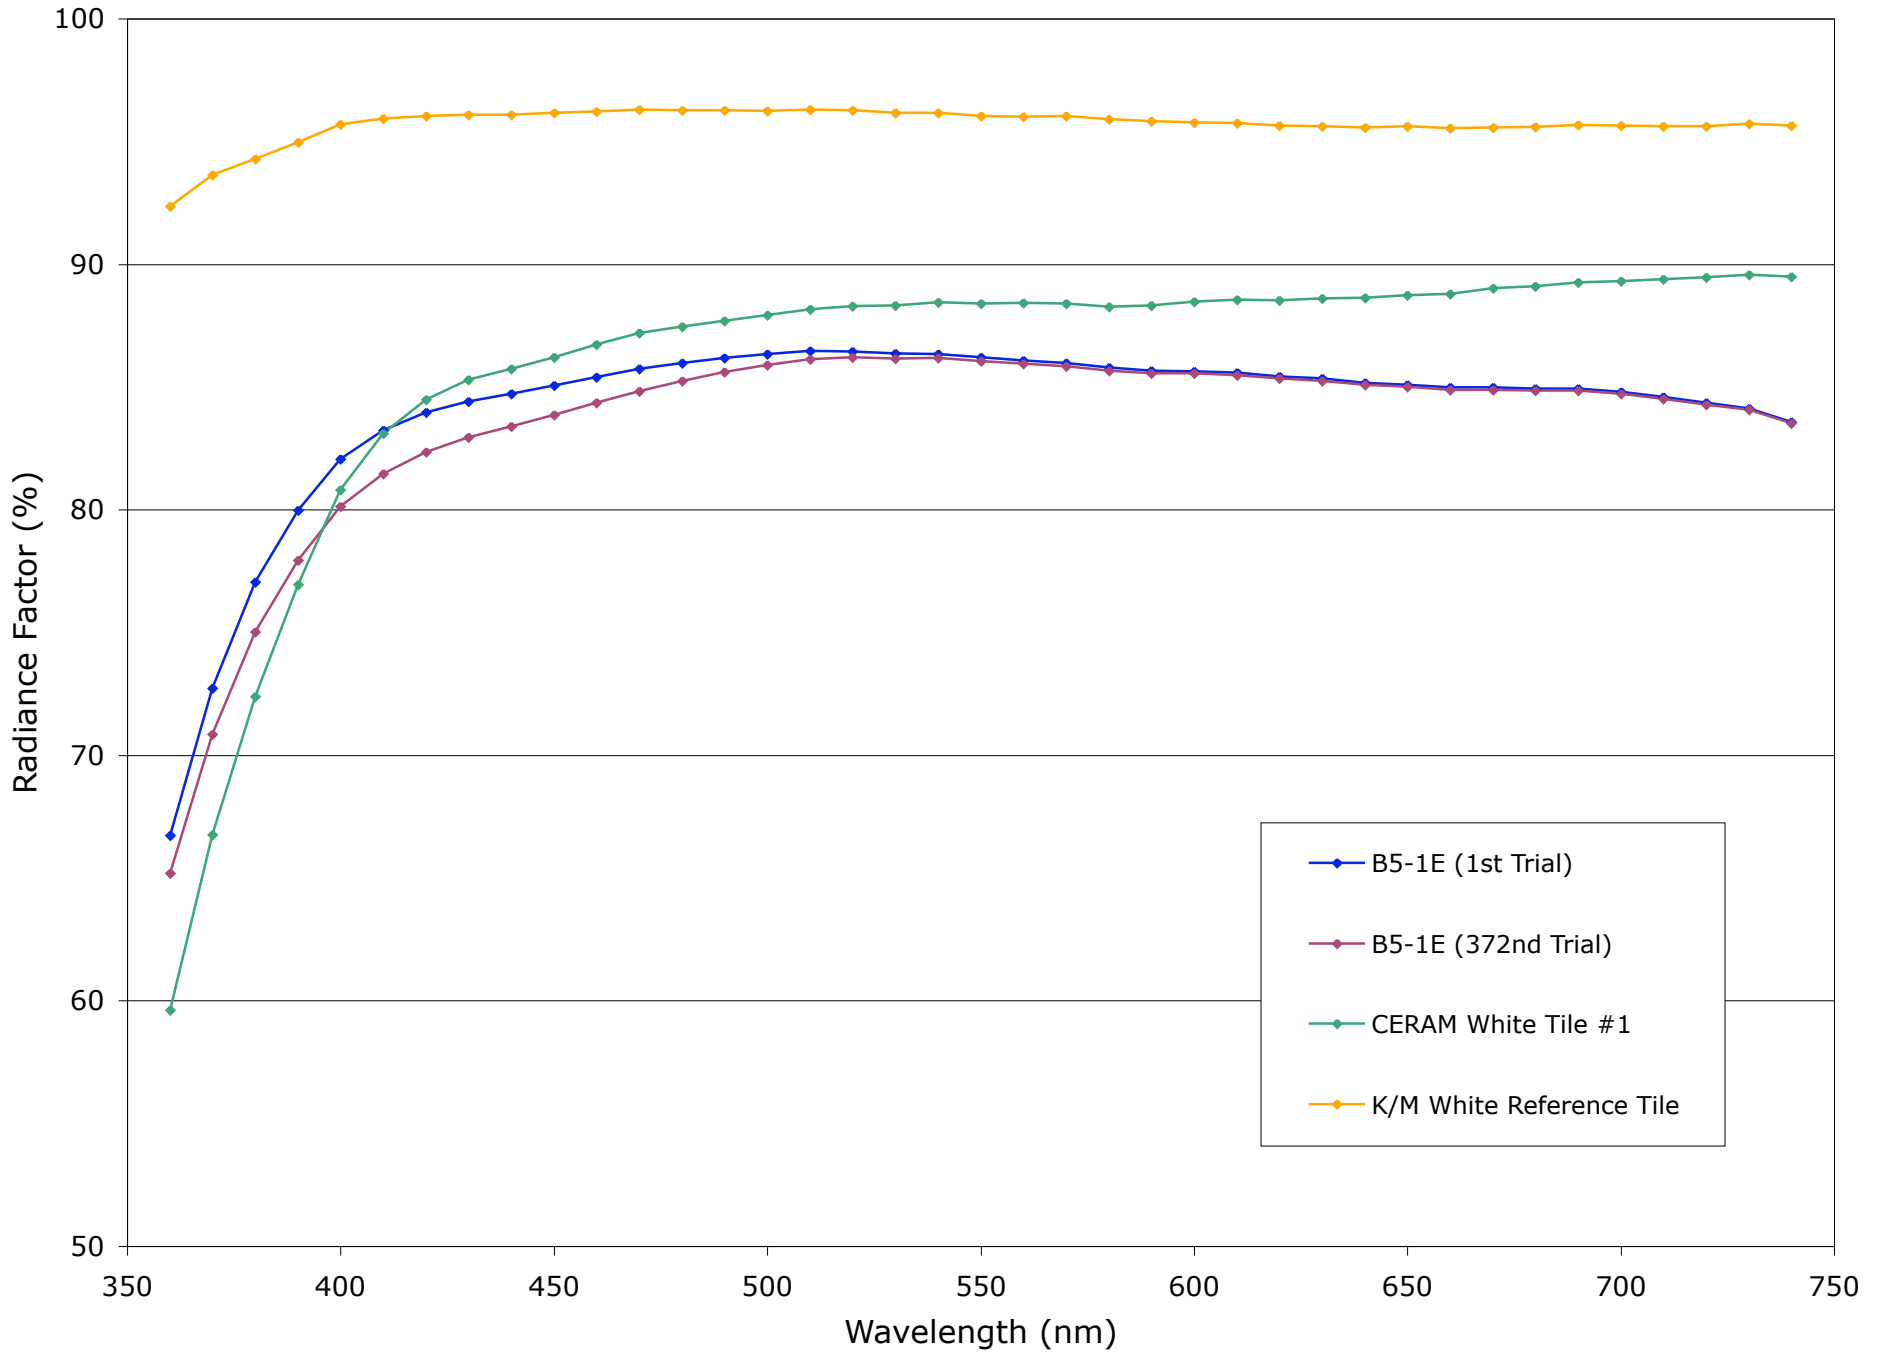
Comparison of UV-Exposed B5-1 Tile with Other White Standards
